Mach Lake Dam (MO 30133).  
Mississippi - Kaskaskia - St. Louis River  
Basin, Perry County, Missouri. Phase I  
Inspection Report.

SUBJECT: Mach Lake Dam Phase I Inspection Report

MACH LAKE DAM  
PERRY COUNTY, MISSOURI  
MISSOURI INVENTORY NO. 30133

PHASE I INSPECTION REPORT  
NATIONAL DAM SAFETY PROGRAM

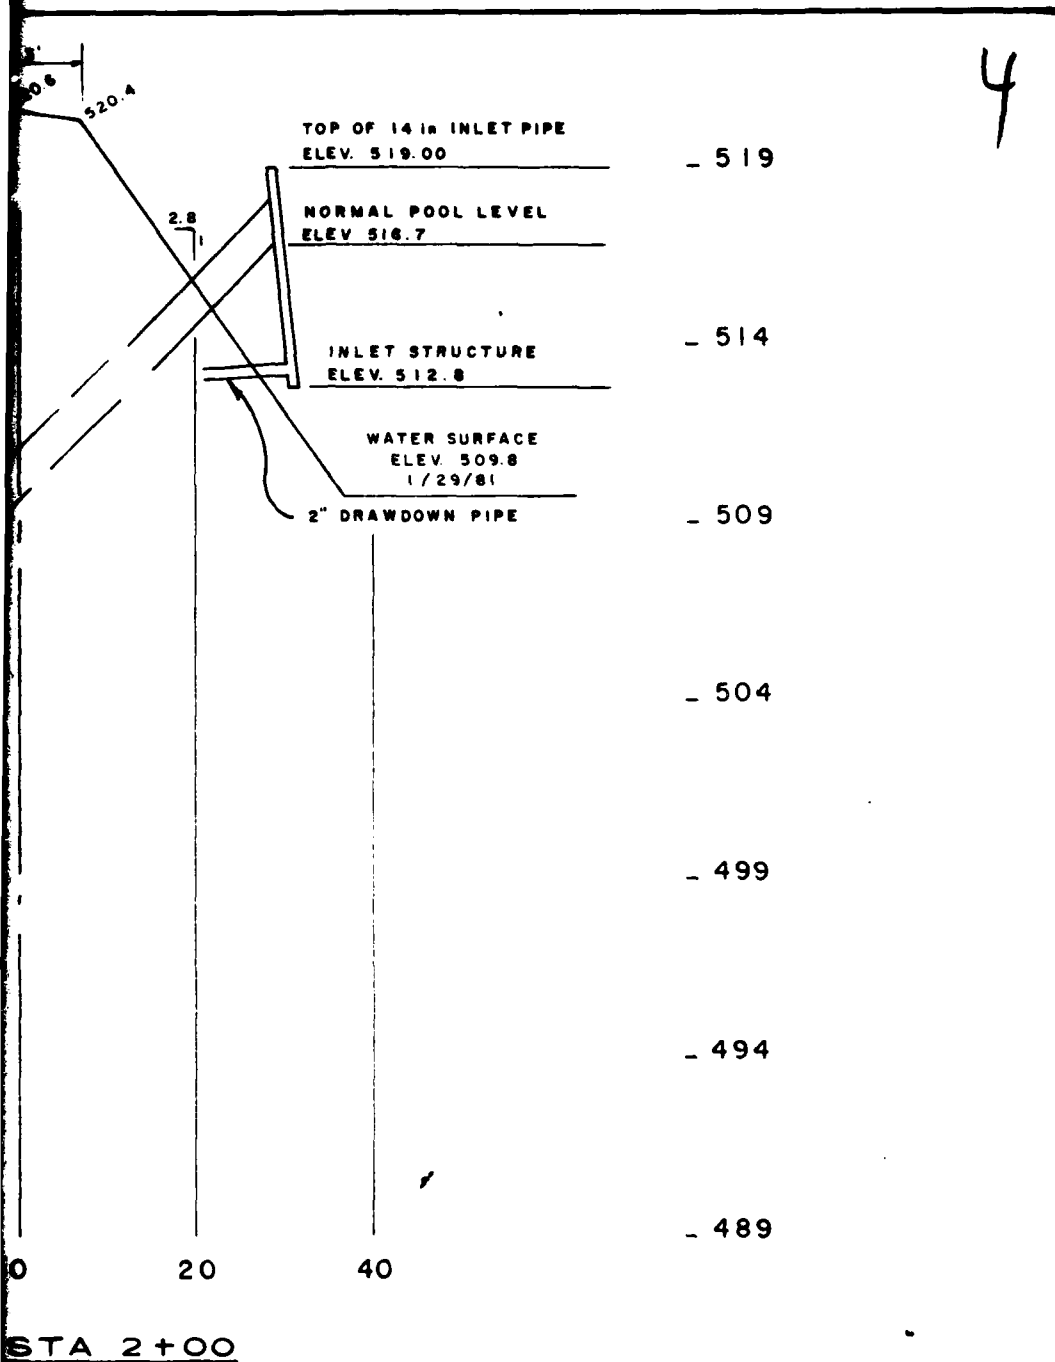
**SHEET 4, APPENDIX A**

A large inactive slough was noted on the downstream face of the embankment. The slough was at station 1 + 50 and at about the mid-height of the dam. The slough was approximately 25 feet across and a large mound of soil was at the base of the slough. The slough appears to be a slope failure and may be the slide referred to in the Geologist's report of April 6, 1973 (see sheet 4 of Appendix B).
